**INFLUENCE OF ENGINEERING PROPERTIES OF THE SOIL,
GEOLOGICAL AND HYDROMETEROLOGY FACTORS ON
FAILURES AND DISTRESS OF EARTH DAMS
IN NORTH-EASTERN NIGERIA**

**A thesis in the Department of
AGRICULTURAL AND ENVIRONMENTAL ENGINEERING**

DOCTOR OF PHILOSOPHY

UNIVERSITY OF IBADAN

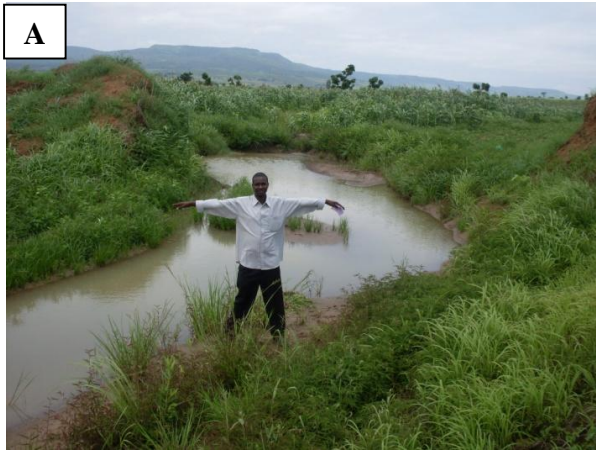
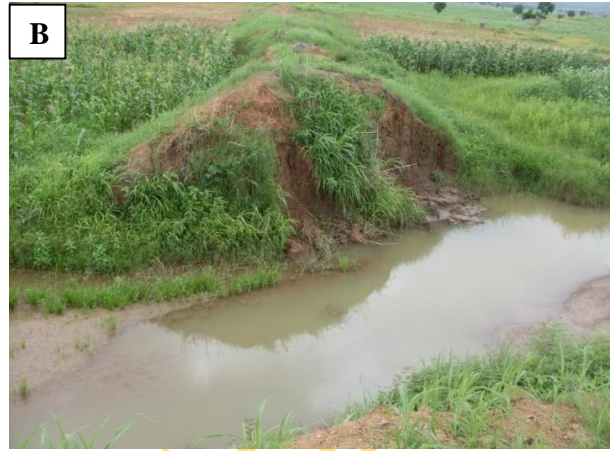
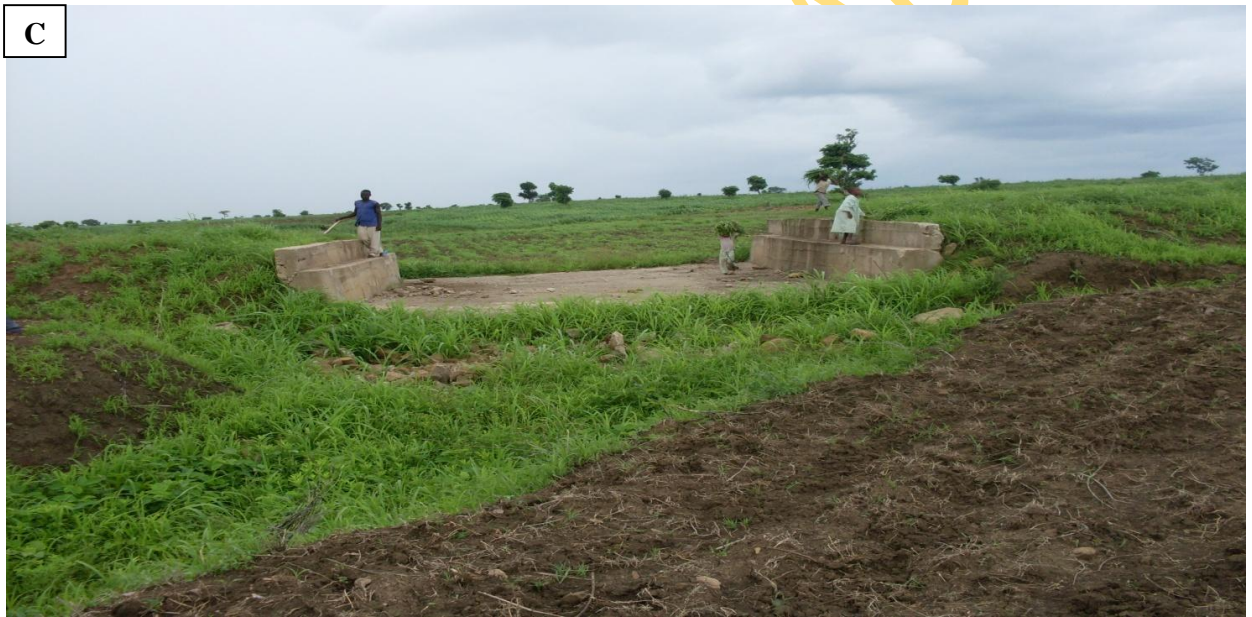
Fig 4.14; Babam dam failure

The soil material is a poorly graded sand (SP) with medium plasticity (PI of 20%) indicating an excellent embankment construction material (Singh, 2001). The CBR of 11% indicates that the material can be affected by compression when poorly compacted (Murthy, 2008). The CBR can be improved by addition of Cement Kiln Dust according to Iorliam *et al*, (2012). The soil material has good shear strength with cohesion of 100KN/m² and angle of internal friction of 5⁰ giving the material additional advantage as an embankment construction material.

The design height of the was not achieved when the contractor left the site and was paid off. Compaction was achieved using a dozer which usually does not give good results. Bambam dam failed hydraulically when the reservoir water overtopped the otherwise short and settled embankment forming a complete breach of the dam with the stream water passing through freely (Figure 4.14A-C).

- A; Embankment completely breached allowing the stream to pass freely
- B; A section through the embankment failure
- C; Spillway improperly located to carry excess flood

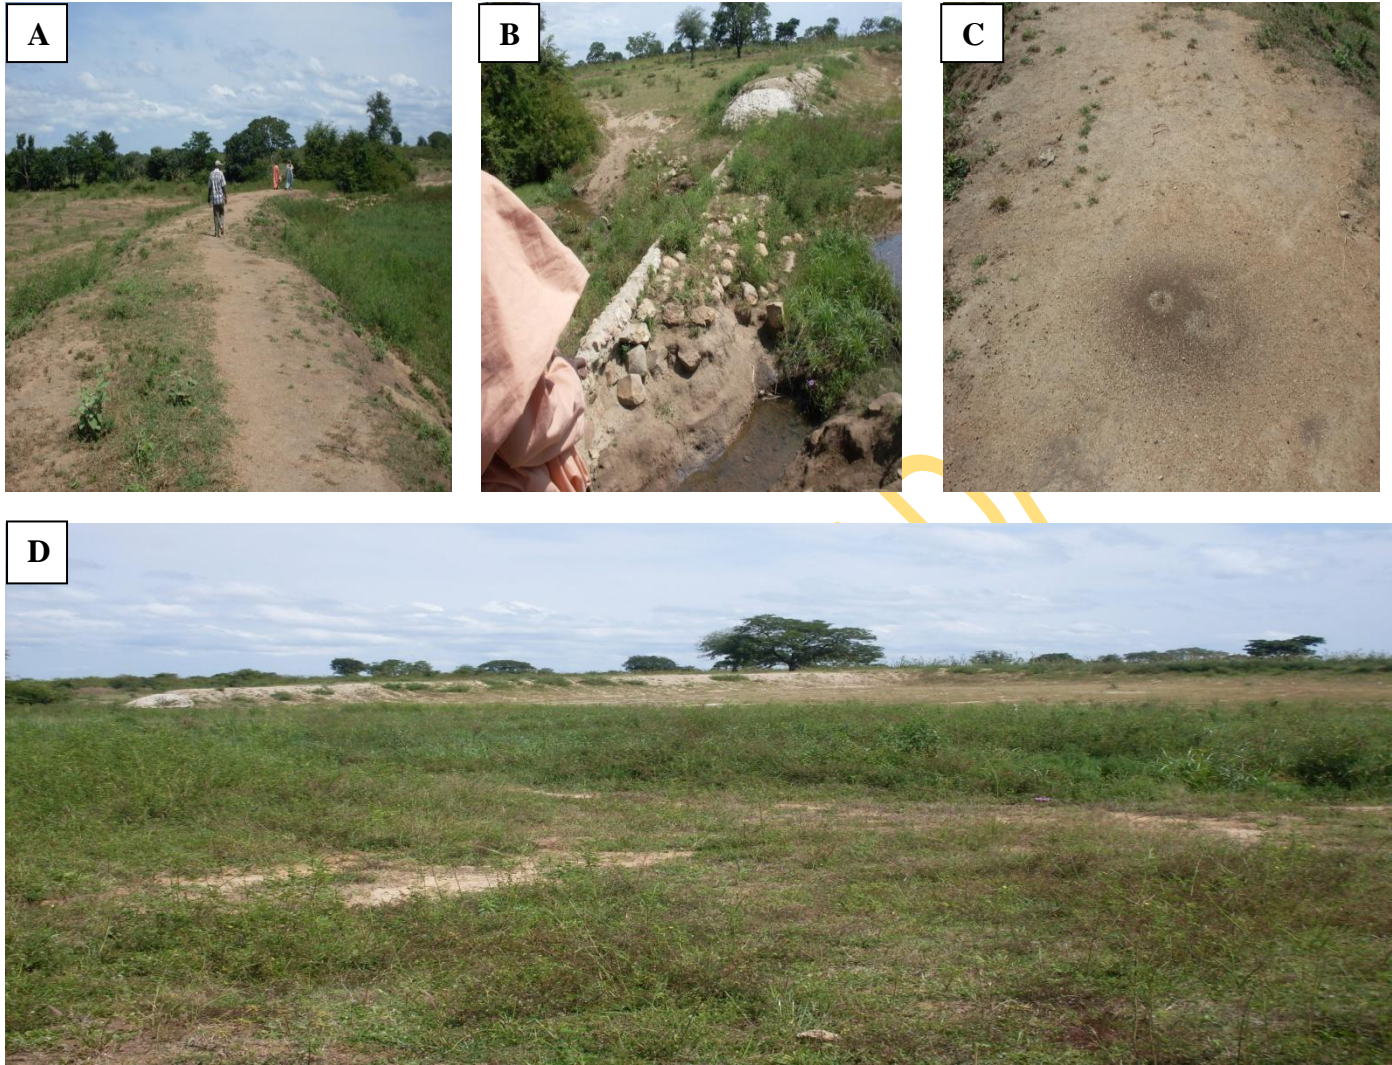
Fig 4.15; Dull Dam Failure

Dull dam failed as a result of a poorly constructed spillway which gave way during the first filling of the reservoir. The stone pitched spillway was fixed without a good foundation. These explains why the spillway failed and the embankment remained intact, allowing all the reservoir water to drain completely through the broken spillway. The appearance of ants infestation on the crest shows a sign of danger from seepage and probably piping (Figure 4.15A-D).

- A; A poorly compacted embankment**
- B; Lack of foundation and poorly stone pitch spillway led to its failure**
- C; Ants infestation on the embankment**
- D; Embankment without any riprap or turfing sod**

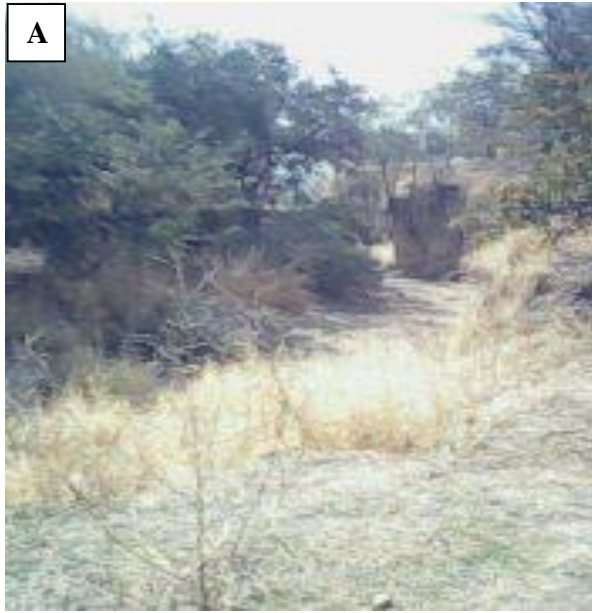
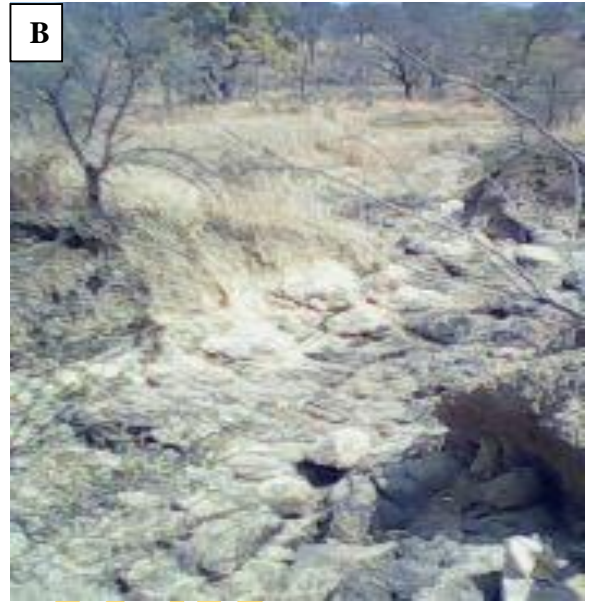
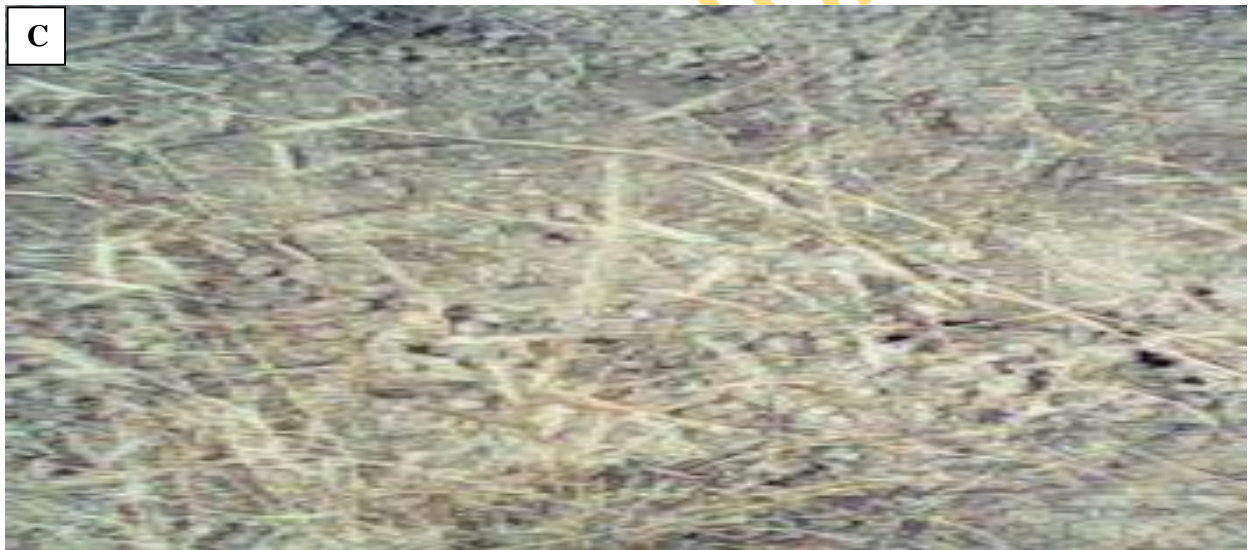
Fig 4.16; Guyaku grasing reserve dam 5 failure

Deep wide cracks were observed on the underlining soils around the surrounding area where the dam was constructed. The dam was never utilized and hence maintenance was not affected for any reason (Figure 4.16A-C).

- A; Gully cut across the embankment
- B; Embankment erosion
- C; Insitu soil conditions at dam site

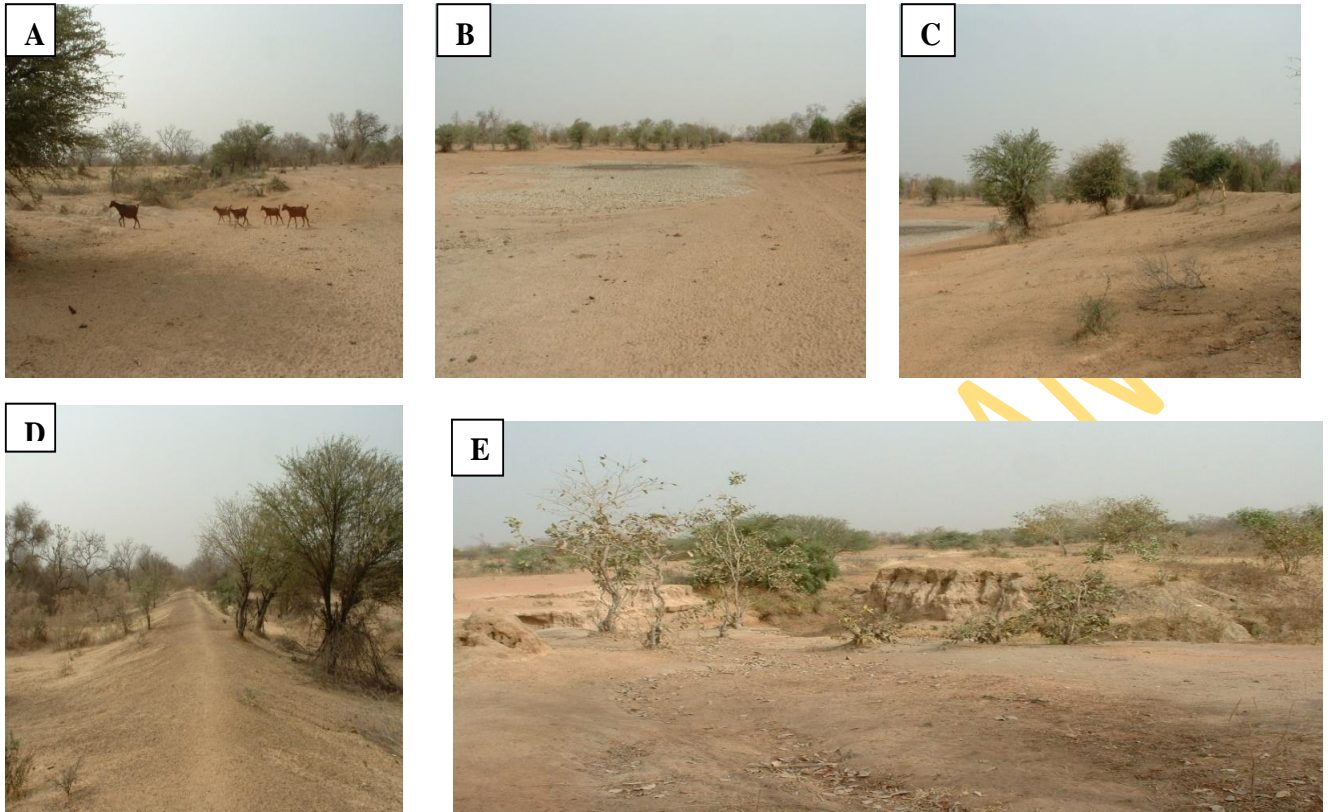
Fig 4.17; Nasarawo gangoshi grazing reserve dam2 failure

- A; Land use and environmental factors encouraged erosion at dam site
- B; Siltation of reservoir
- C; Reduction of reservoir volume and embankment height
- D; Trees on the embankment
- E; Gully formed at the abutment of the embankment

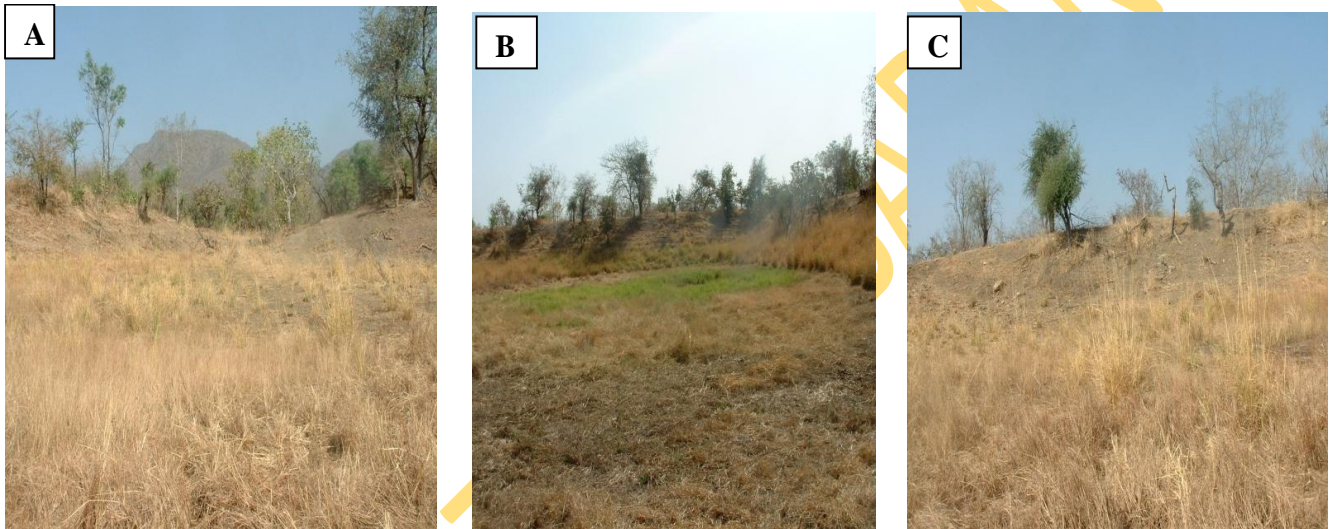
Fig 4.18; Sarau Belel Grazing Reserve Dam2 Failure

- A; Channel recharging the reservoir diverted overtime due to lack of maintenance
- B; Empty reservoir indicating hydraulic failure
- C; A poorly maintained embankment with trees growing on it

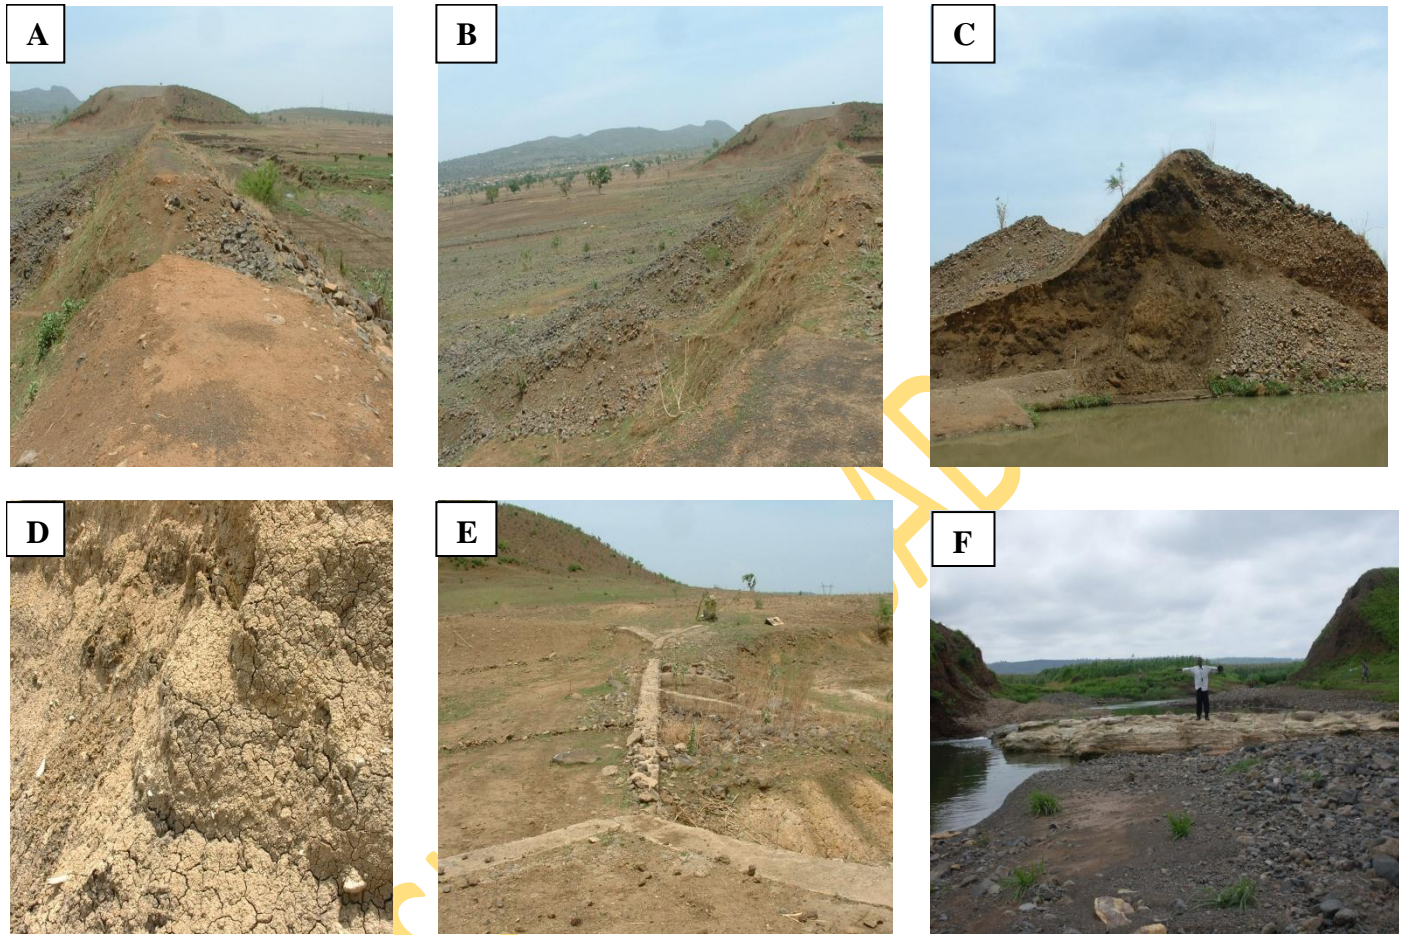
Fig 4.19; Cham Dam Failure

The spillway of the dam was not completed signifying danger to the dam during high inflows. Again, the design height of the dam was not achieved when the dam was hurriedly commissioned in 1992. The dam was constructed without following the design specifications. Two different designs were found for the dam cross-section; one design drawing shows a zoned embankment with clearly delineated zones of central impervious core flanked with zones of pervious shells while the other one does not contain such zonings. Physical examination of the dam cross-section along the breach shows a homogeneous embankment with a mismatch of clayey to gravel size particles with no clear zoning. These are the major reasons for failure. A similar phenomenon was observed on world population of dams by Foster (2000) and Foster et al, (2000). The dam failed hydraulically and structurally when it was overtopped by a flashflood which undermines the height of the shortened embankment with uncompleted spillway and a very small outlet which could not drain the reservoir fast enough. With the absence of zoning a complete breach of the embankment resulted in the cutting of the dam up to foundation level, allowing the river to pass across the dam freely (Figure 4.19A-F).

- A; Settlement and slope failures at different parts of the embankment
- B; Absence of toe drain or toe weir at downstream seepage path
- C; A section through the embankment at failure point
- D; A close look at the soil material
- E; The uncompleted spillway (Broad crested weir)
- F; Section where the breach cut the dam axis at its lowest

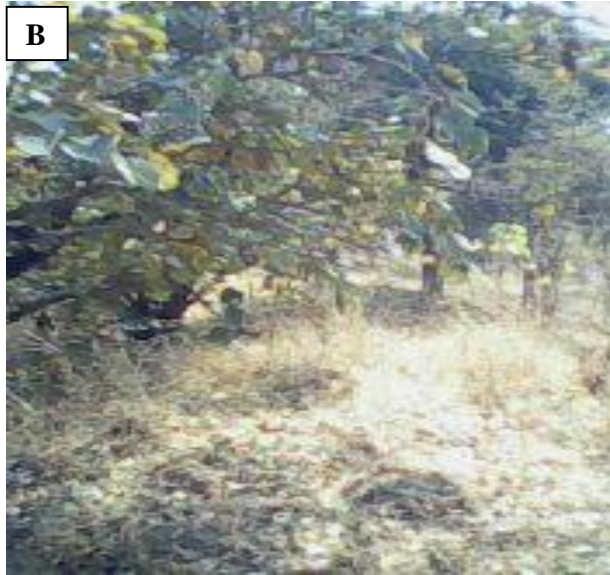
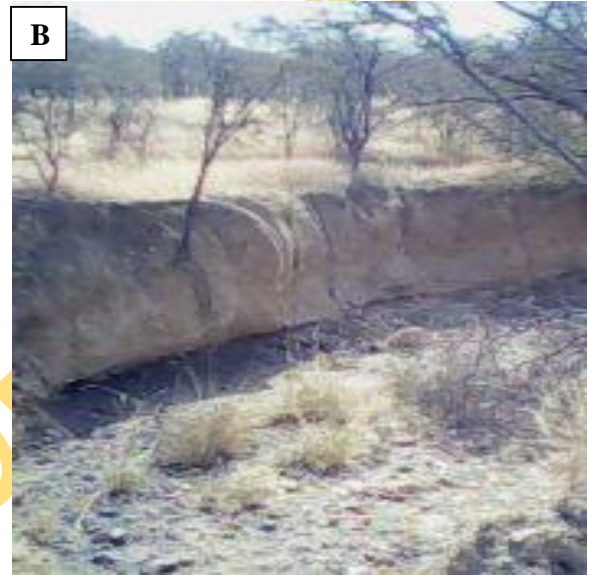
Fig 4.20; Guyaku Grazing reserve Dam2 failure

Loose unstable and fissured soils were observed at the dam site, showing the presence of expansive soils at site (Figure 4.20A-B).

A; Trees and shrubs growing on embankment

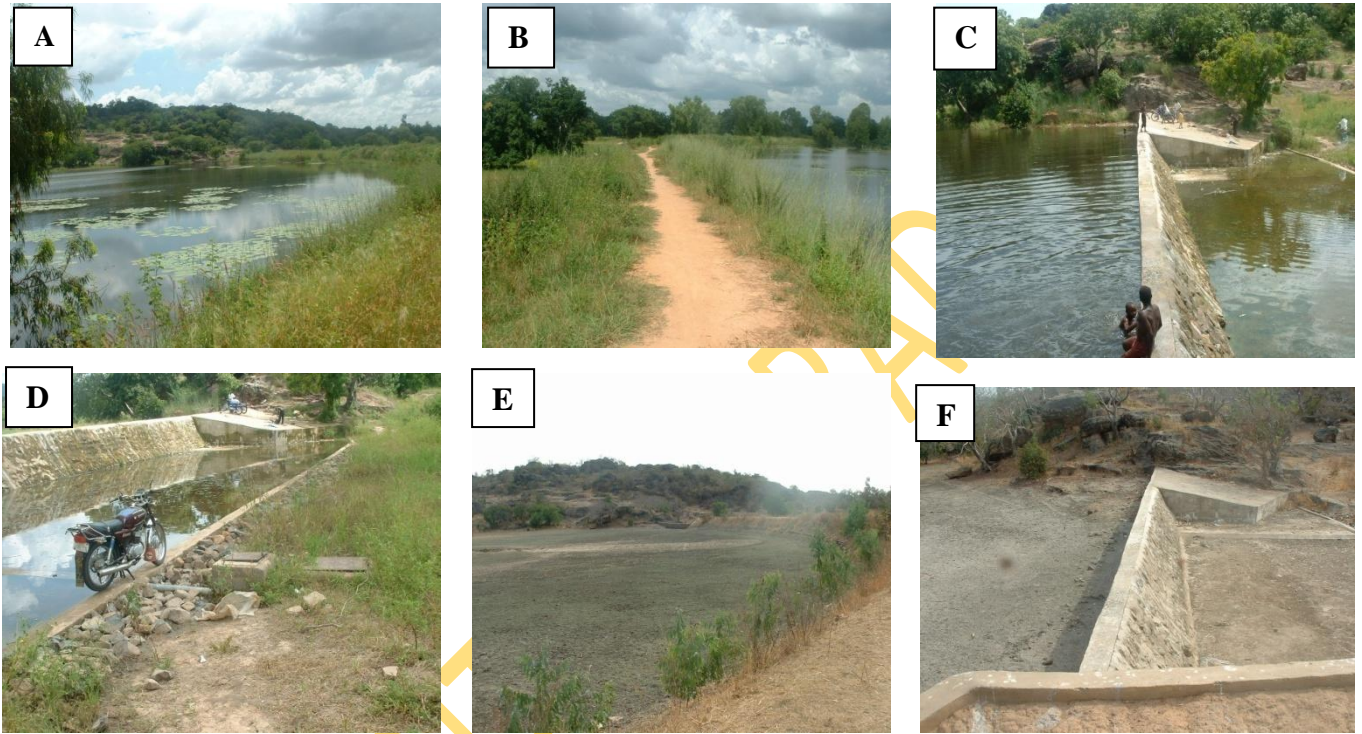
Fig 4.21; Girei Earth Dam

The embankment soil material is a poorly graded sand of medium plasticity (13%) with a CBR of 40% indicating a very good construction material that can be stable (Singh, 2001) along with a permeability of 2.233×10^{-8} (relatively impervious) giving it an additional advantage. The material also has good shear strength with cohesion of 74 kN/m^2 and angle of internal friction of 5° (Murthy, 2008). This explains the unique failure of Girei dam where the embankment remains intact while the reservoir remains empty for greater part of the year. The reservoir dries up almost immediately after the rains. Girei dam failed essentially as a result of seepage, with spillway failure and high evaporation from the reservoir area (Figure 4.21A-F).

- A; Reservoir contains water during rainy season
- B; Stable embankment with grasses growing on top
- C; Spillway about to spill downstream
- D; Seepage water observed in the stilling basin
- E; Reservoir empty during dry season
- F; Dry spillway in the dry season

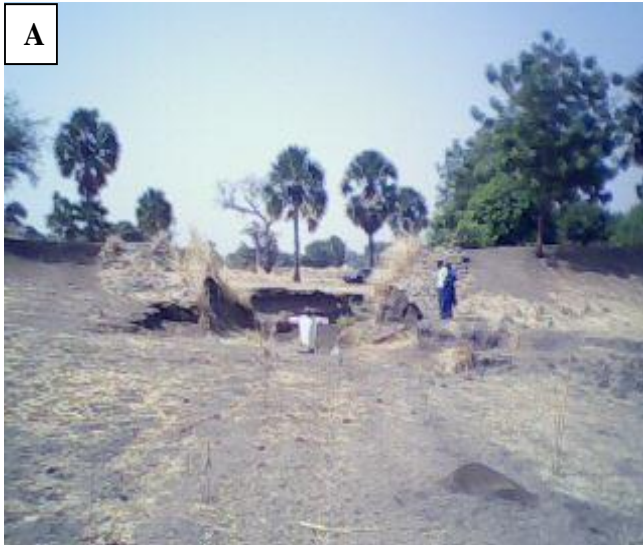
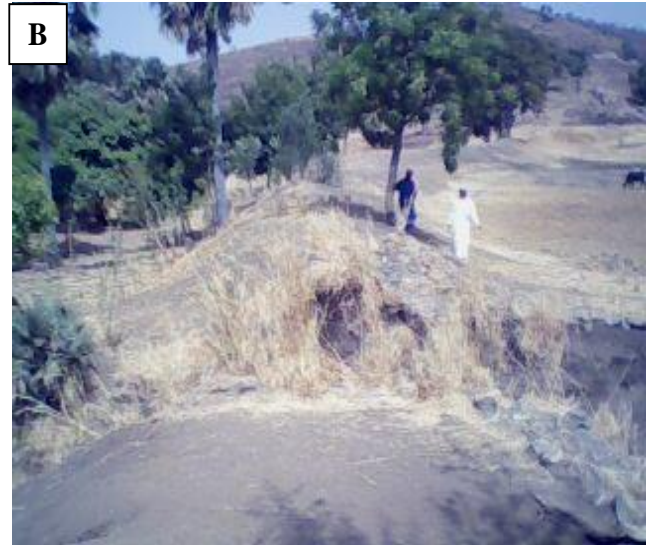
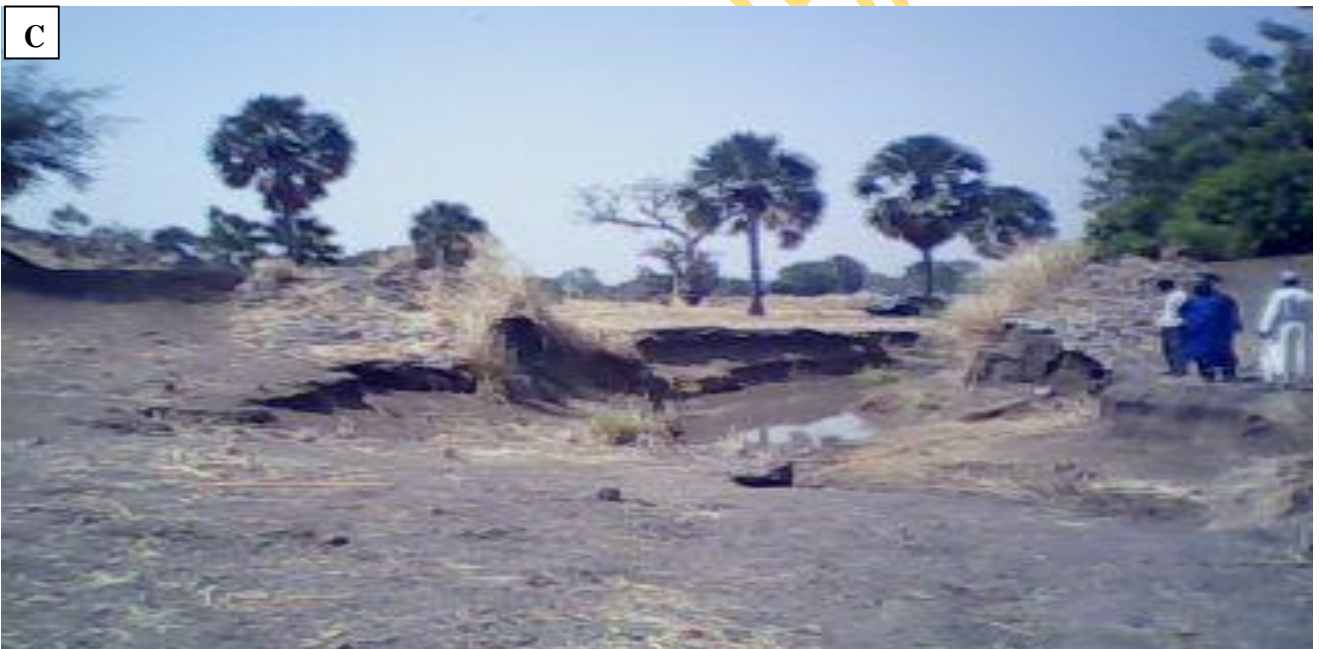
Fig 4.22; Nzuzu dam failure

The dam failed as a result of poor construction of the spillway coupled with general lack of maintenance of the dam. The stone pitched spillway gave way after a heavy storm. The flood breached the embankment below original ground level, retracing the original stream downstream. Animals also stampede the embankment further weakening it and aggravating erosion problems. There is no slope protection of any kind for the dam. The impounded water in the reservoir escaped through the eroded spillway, flooding some parts of Garkida town (Figure 4.22A-C).

- A; Spillway failure allows water to pass freely through the embankment
- B; Big trees growing on embankment
- C; Reservoir emptied through the failed spillway

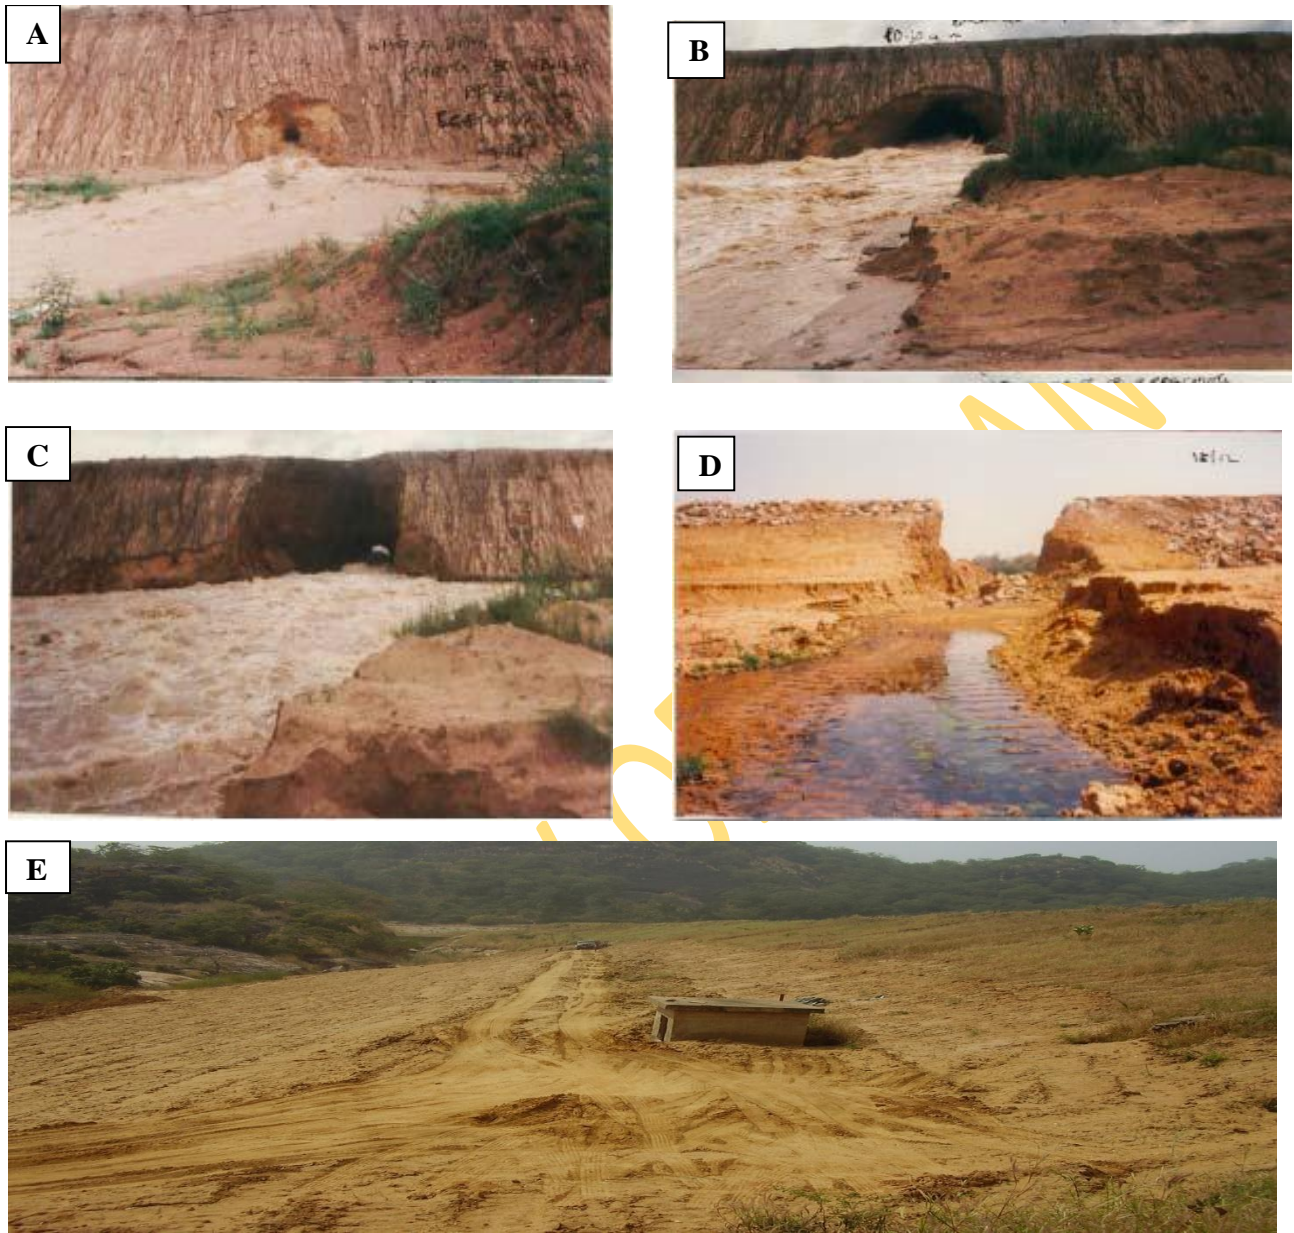
Fig 4.23; Waya Dam Failure (Seepage and piping failure)
(source: Bada, 2008)

- A; Piping 45mins after seepage was observed
- B; Piping 2hrs 30mins after seepage was observed
- C; 9hrs 30mins after piping was observed
- D; Breached section of dam
- E; Rehabilitation work on progress on the downstream shell

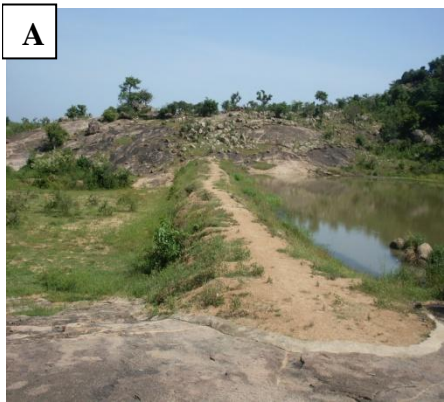
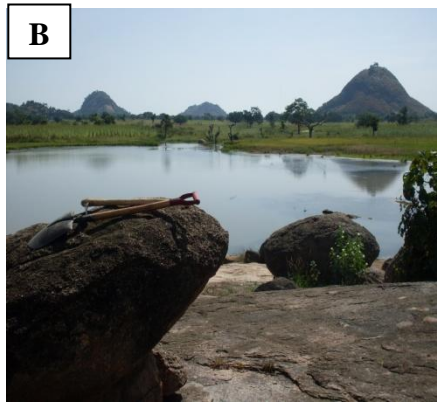
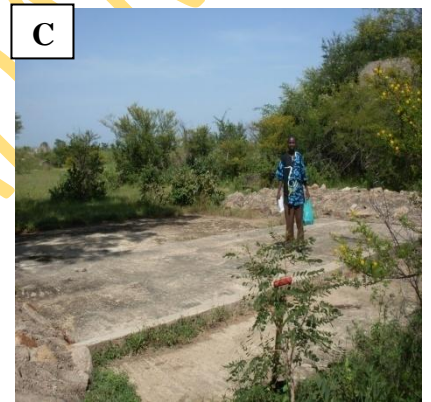
Fig 4.24; Miri Distressed Dam

- A; A poorly constructed and poorly maintained embankment
- B; A big life reservoir supported by this small embankment
- C; Spillway designed and constructed without achieving the desired result

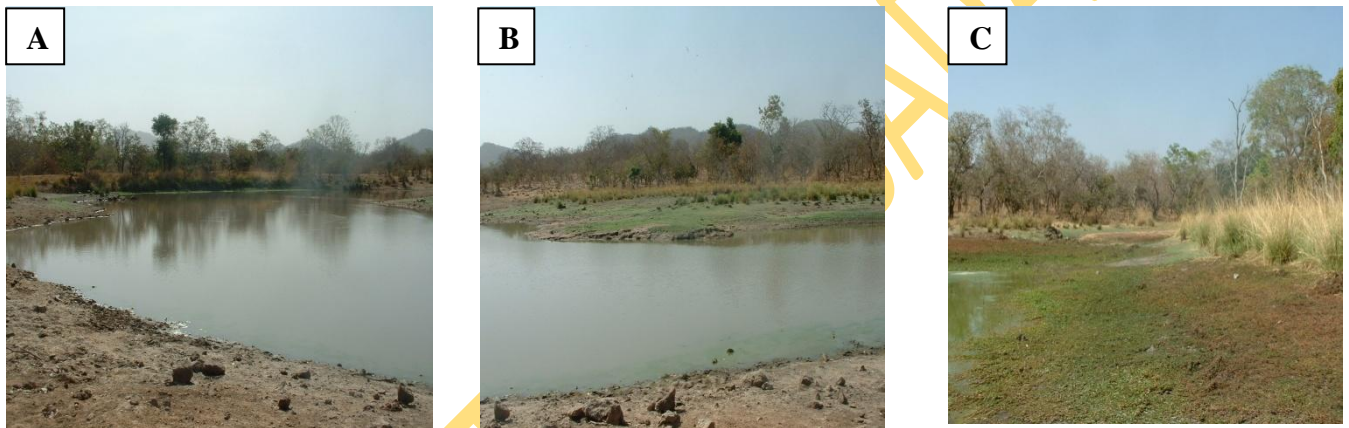
Fig 4.25; Sarau Belel Grazing Reserve Distressed Dam3

- A; Progressive siltation of reservoir
- B; Poorly maintained embankment and a reduced reservoir capacity
- C; Recharge channel poorly maintained

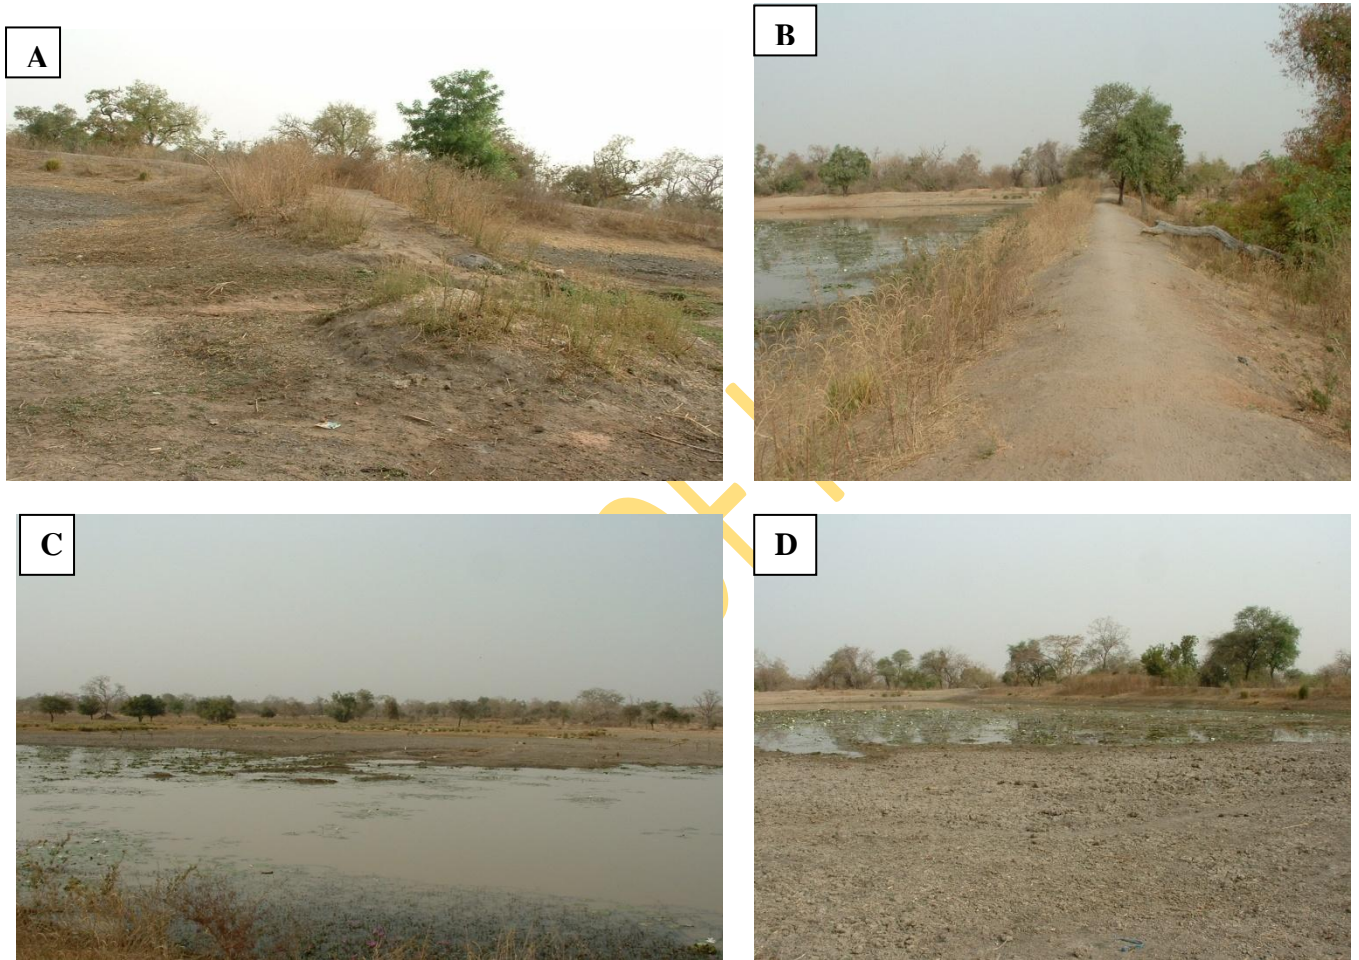
Fig 4.26; Nasarawo Gongoshi Grazing Reserve Distressed Dam1

- A; Poorly maintained embankment with excessive erosion and no definite spillway
- B; Trees growing on embankment, people and animals move on the bare embankment
- C; Progressive siltation of the reservoir
- D; Land use enhances siltation resulting in reduced storage capacity of the reservoir

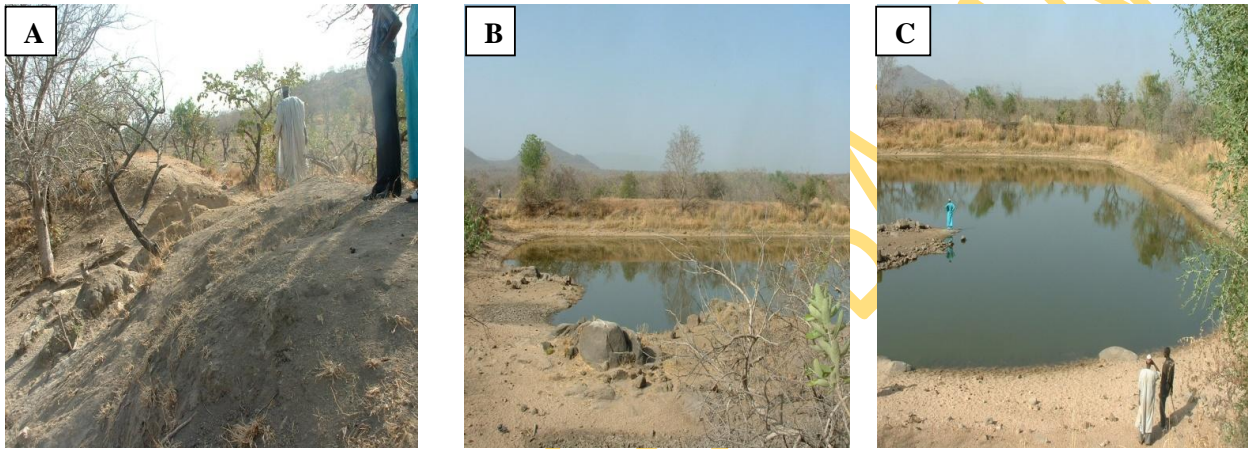
Fig 4.27; Sarau Belel Grazing Reserve Distressed Dam4

The embankment is poorly maintained, with trees and shrubs cover on it. The reservoir is highly silted and embankment is highly eroded at different sections. Animals graze and trample on the embankment further aggravating the erosion problem. The dam may be undermined when the reservoir capacity is directed towards the highly eroded embankment and silted reservoir. Sustained reservoir loading may lead to complete collapse of the dam (Figure 4.27A-C).

- A; A poorly maintained embankment with trees on top, excessive erosion & human and animal traffic aggravating the situation**
- B; Siltation of reservoir and absence of a definite spillway**
- C; Reduced reservoir capacity as a result of siltation**
