**INTERNATIONAL JOURNAL OF
ENVIRONMENTAL ISSUES**

CAUSES AND PREVENTION OF EROSION IN URBAN CENTRES: A CASE OF OKEITUNU/SANNGO AREA OF IBADAN CITY, NIGERIA

O. A. AGBEDE
W. O. AJAGBE

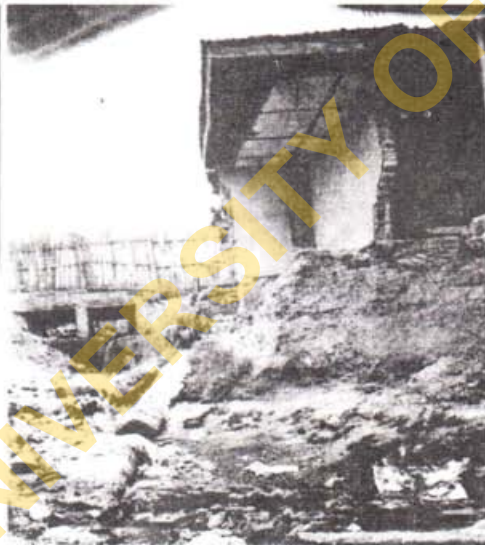
Plate 1: Collapsed Part of a Building Lying in the Flood Plain at Alaro Area.

Alaro/Isopako Area: This is the area where destructive effect of the flood is most felt. The immediate solution is the channelization of Alaro stream to carry a design flood safely from the railway to Ona River at Eleyele. This may involve the demolition of some encroaching buildings on the riverbank.

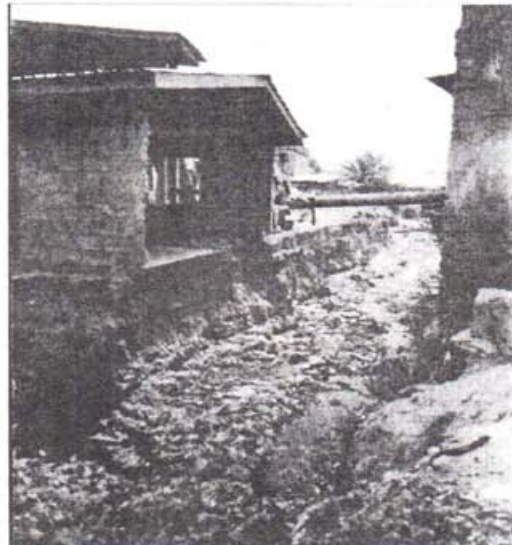
Plate 2: A Building under Threat along Water Channel at Alaro Area.
