*Proceedings of the 2019 Conference on
Sustainable Construction for National Development
Organized by the Department of Civil Engineering,
University of Ibadan*

Assessment of the Impact of Road Dualisation on Adjacent Structures: A Case Study of Iwo-Road – Agodi Gate – Bashorun Road in the Ibadan Metropolis

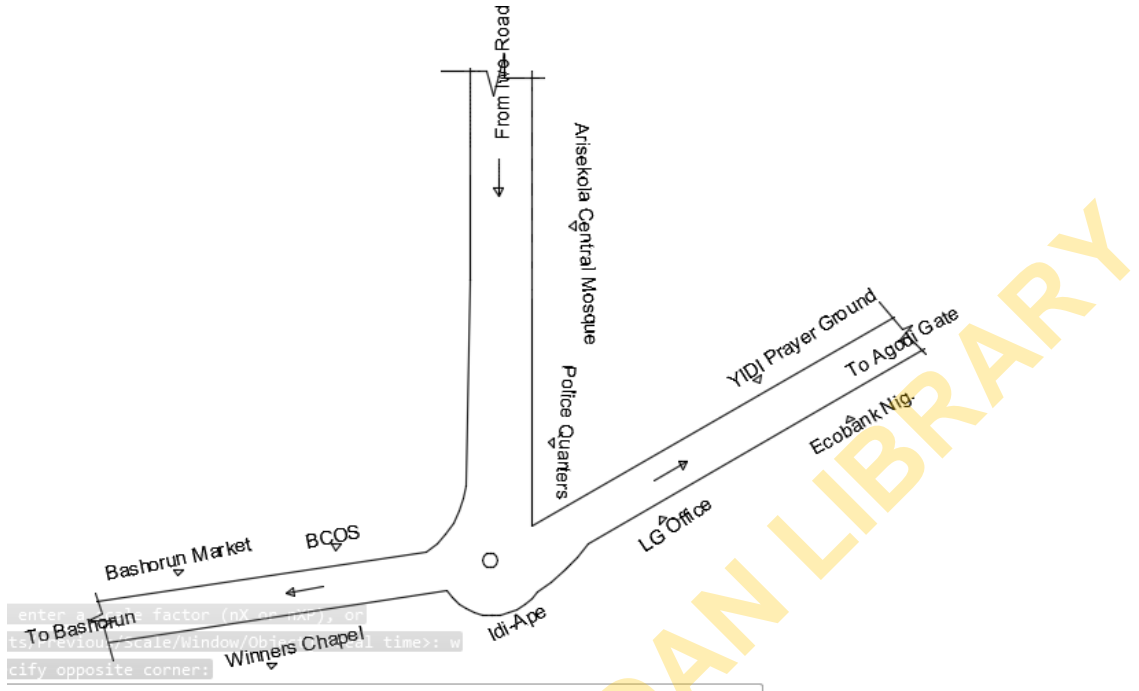
Figure 1: Showing a Sketch of the Road Segments and Notable Locations at Each Segment.

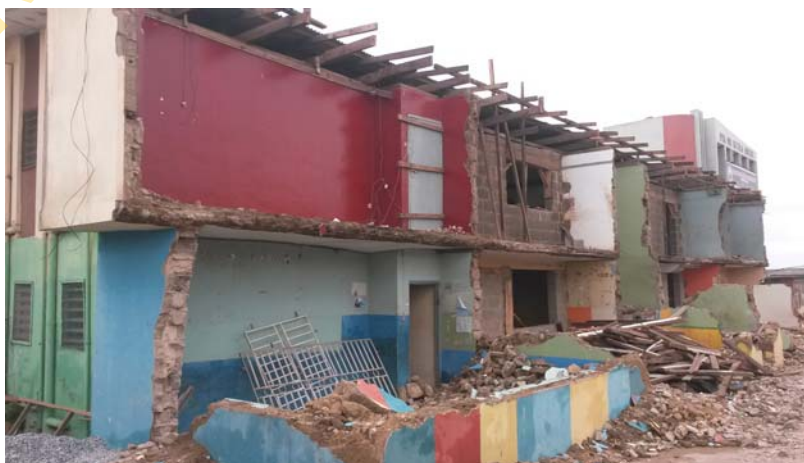
Plate 2. Showing the Partial Demolition State of Case 1

Therefore, since v_t is greater than v_{tmin} and $(v + v_t)$ is greater than 3.58 N/mm^2 or 5.00 N/mm^2 , the beam in the structure experienced additional load away from the plane of bending inducing torsional moment along with the bending and shear forces.

The torsional stress resulted due to the change of initial design and configuration of the extending beams and slabs at the side of the internal continuous beam in distress changing them from simply supported beams to cantilevers.

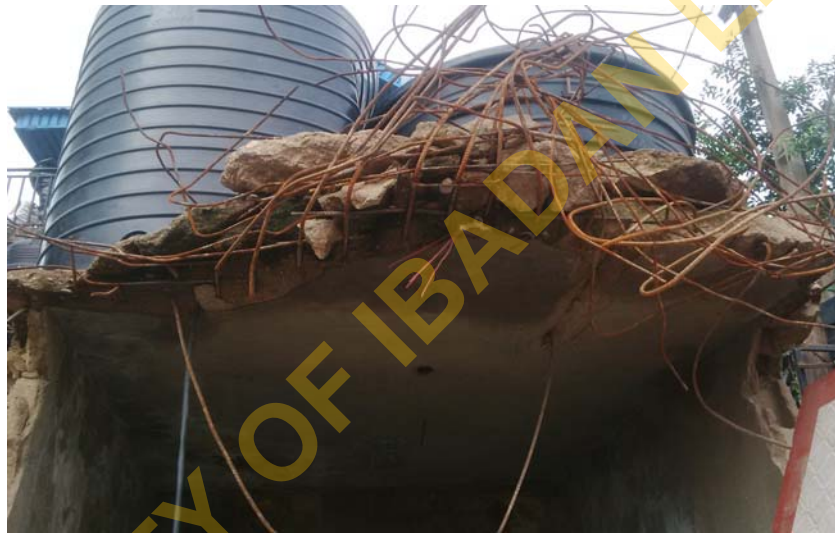
Plate 3. Showing the Partial Demolition State of Case 2

Due to the demolition, there was reduction of the effective critical perimeter hence area of the slab, resulting in higher shear stress due to punching.

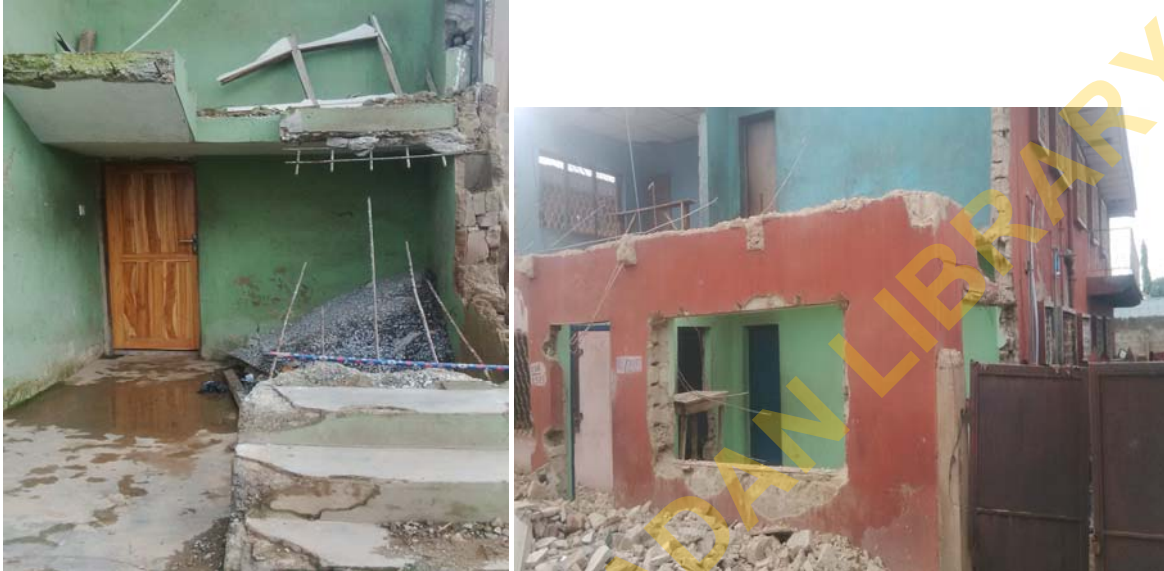
Plates 4 and 5. Showing the partial demolished state of cases 3 and 4

Due to the loss of functionality caused by the demolition of the existing staircase in each building, the stairs helped to provide access to the next floor or storey. Spiral staircases are recommended and designed, for cases 3 and 4 in place of the affected stairs.

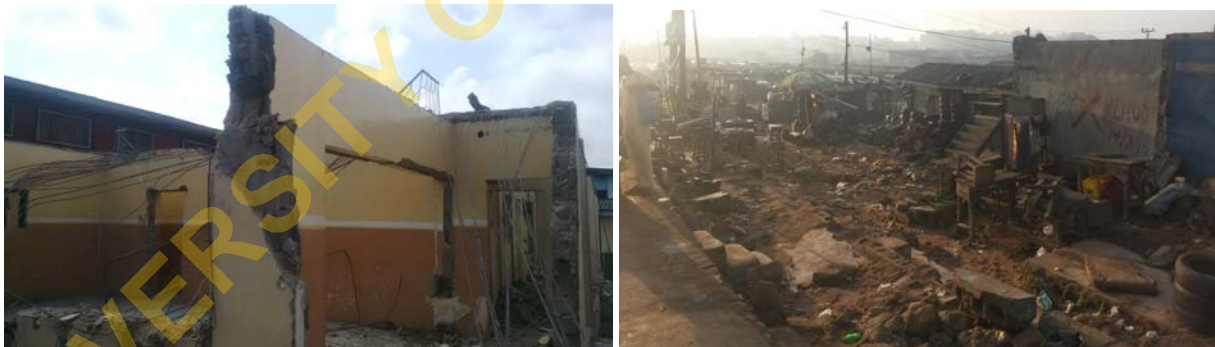
Plates 6 and 7. Showing the Full Demolition of Cases 5 and 6

In this situation, consideration was made for buildings, infrastructures and market stalls that were completely demolished, though analysis were not made on them as a result of their non-functional states.
