# Repair and strengthening of bamboo reinforced acrylic polymer modified square concrete columns using ferrocement jackets

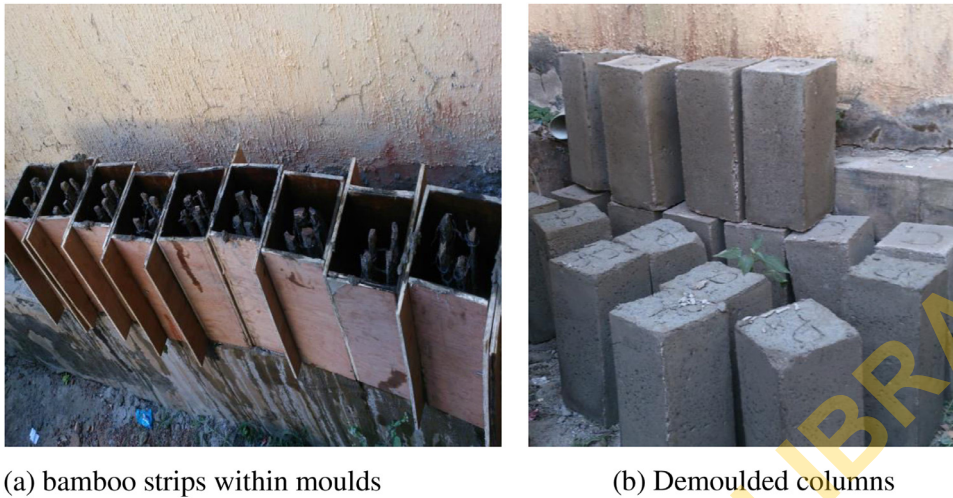
Figure 1. Treated bamboo strips columns.

Bamboo culms from *Bambusa vulgaris* species were obtained from Landmark University with their ages ranging from 4 to 5 years. They were held in a bench vice and subsequently pre-cut into 5×50×450mm. Subsequently, four of these strips were connected together using short steel stirrups to form a column of bamboo reinforcement. The nodes of the bamboo splits were positioned upwards to improve bonding with cement matrix because the bending strength of bamboo is greatly dependent on the position of nodes, which stiffens the culms (stem) at intervals thereby preventing buckling or collapse of the columns. These pieces were approximately 100mm apart from each other with an average thickness of 0.4 - 0.6 cm. OCI 934H Super bond adhesive which is a bitumen based thermosetting adhesive was applied on the surface on the bamboo columns. Thereafter, for good bond with the concrete, fine sand was applied on the adhesive coated surface to produce a

simulated ribbed surface similar to that of steel bars which would improve the bond to the concrete. The bamboo columns were then stacked on top of each other and placed on a flat surface for air drying in the laboratory at 23 °C for 14 days.

Ten numbers of 5 × 150 × 600mm (Figure 2) wooden columns were utilised for the experiment while a total of 30 columns were produced for the tests. Table 1 was used to produce the two different types of mortar reinforced columns. The first has conventional cement mortars (without acrylic polymer modification) while the second group were for acrylic polymer modified concrete. Subsequently, small portions of the matrix were poured into all the 10 moulds and the already treated bamboo columns were placed inside them (Figure 1a). The reinforcements were vibrated manually for some seconds to allow the concrete to encapsulate them and also to eliminate voids at the edges and the nodal region. The remaining empty part of the columns were later filled up with concrete and allowed to cure in the air for 24 hours before they were demoulded (Figure 1b).

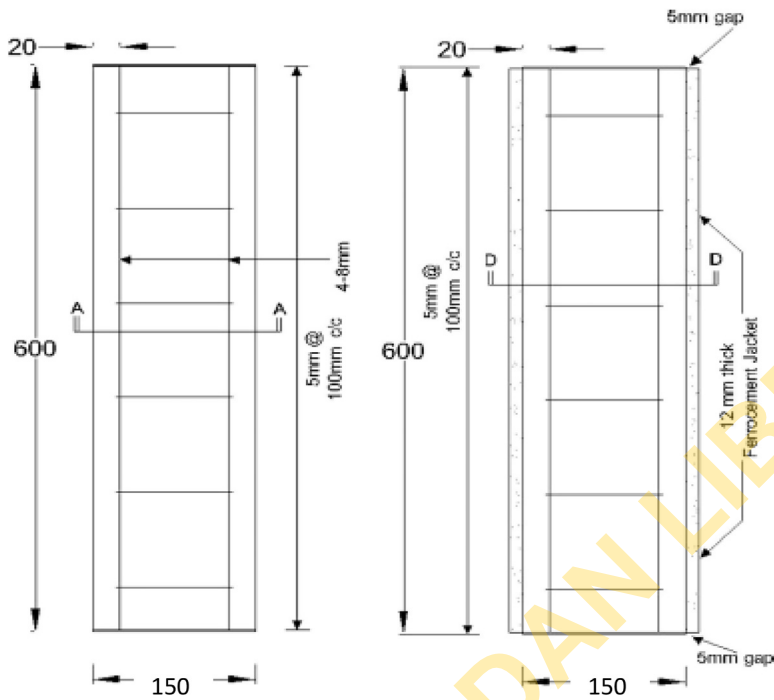
Figure 2. Schematic diagram of ferrocement jacketed bamboo column [33].

For column groups P<sub>11-15</sub> and C<sub>11-15</sub> which required ferrocement jacket before the tests, the edges were chipped off to a radius of 20 mm from one side to the other. This was done for the entire 4 edges of the square column to give a round edge and for proper adhesion between the applied mortar layer and concrete surface. Thereafter, the bundle of the wire mesh was placed around the columns with an allowance of 15mm at the top and bottom of the columns. The mortar was applied on the surface layers of the columns through the mesh until they were completely covered. This was done for the already cured samples that needed to be ferrocement jacketed before the test in order to improve the uniform lateral confinement [29].

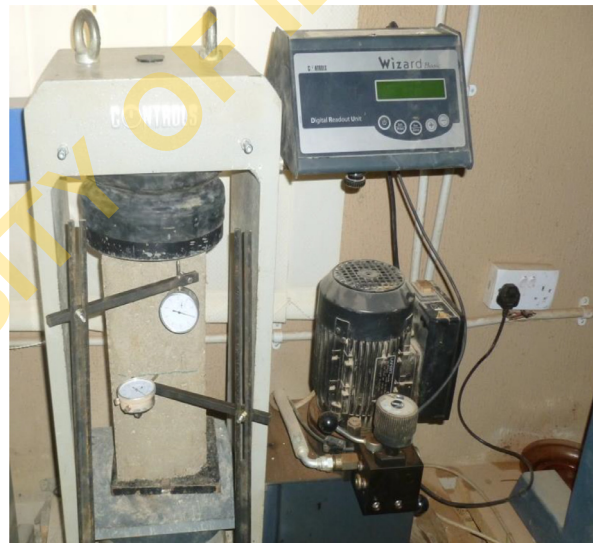
Figure 3. Test set up.

Two sets of metal stand were used to hold dial gauges during the test without any form of contact with the specimens and the machine in order to give an accurate reading of the dials. The axial deflection at the top plate and the lateral deflections at the mid-point of the column specimens were measured with dials gauges. The load was applied at the top of the column and the failure was observed while the corresponding ultimate load was recorded (Figure 3).

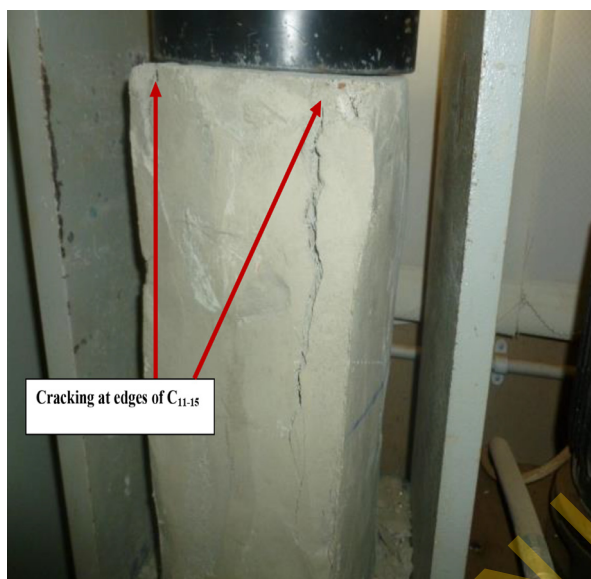
Figure 4. Cracking at edges.

Failure of the specimens commenced by cracking in the ferrocement jacket. The applied load resulted into stress concentrating on the ferrocement jacket which developed into initial cracking at these points of stress. Cracking occurred at the edges of the C<sub>11-15</sub> samples because of stress concentration while cracking took place at the center of each face for the P<sub>11-15</sub>-type columns because the stress concentration has been reduced due to the presence of rounded corners. Points of curvature change also experienced cracks as these points are known for their stress concentration areas. For the other concrete columns, occurrence of cracks took place at the center of each column face and at the corners. These were responsible for the peeling and bulging of the mortar layer from the specimen as observed in Figure 4.

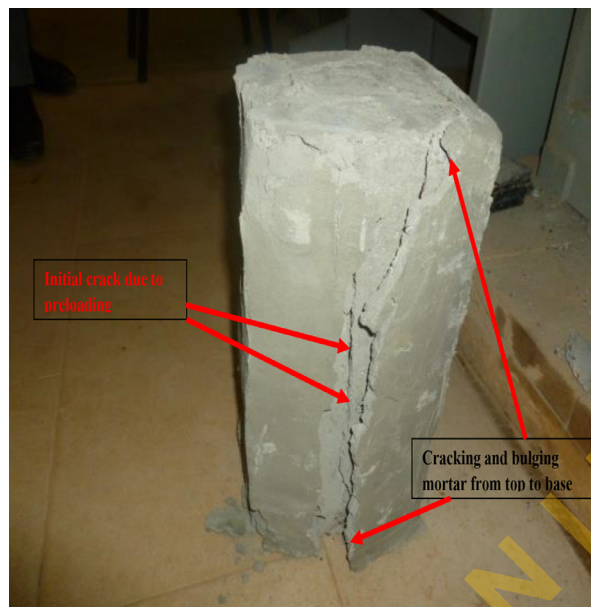
Figure 5. Initial crack, bulging and peeling of mortar.

Repaired preloaded columns failure occurred gradually by bulging and cracking of the mortar that was worked through the mesh of the ferrocement jacket during the repair process at the upper part of the specimen. It progressed downwards (Figure 5) while failure of the C<sub>6-10</sub> occurred near the corners. Progressive failure mode was observed as a result of the initial damage triggered by preloading the columns to 25%, 50% and 75% of ultimate load. All the tested concrete columns started to fail at the upper level in contact with the loading plate. This might have been due to the strong internal confinement of bamboo reinforcement within columns supplied by the metal tie bars. The crushing levels and cracking along with the height in both types of samples were almost the same because of the comparable tie bar connections in all the types of specimens.
