## EVALUATION OF SOME FARM STRUCTURES IN SOUTH WESTERN NIGERIA

### ABSTRACT

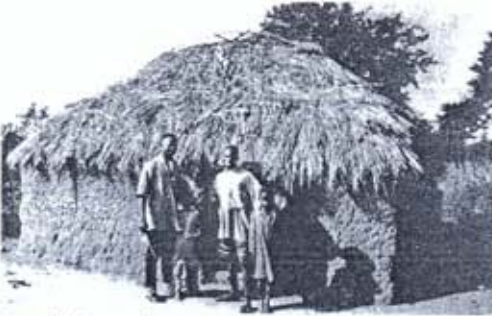
Plate 1: Farm house of mud wall and thatch roof

Structure	Materials of construction	Problems experienced	Remedial measures
Farm Houses	Those used by small holder farmers are of rammed earth floor and a thatched roof supported either by wooden poles or mud walls while for those in large scale farms, conventional building materials such as concrete floors, walls of sandcrete blocks, trusses from sawn timber and iron roofing sheets are used.	Problems are - more experienced with those used by small holder farmers because of the materials used. These include the erosion of mud walls which occasionally develop to cracks, the thatching material is often attacked by termites in addition to drying and thinning resulting in leakage.	Cracks filling and plastering with mud at regular intervals and in a few instances cement mortar is used, replenishment of thatch materials
Cribs	Small diameter logs, palm fronds or split bamboo for the floor and walls, and a thatched roof rested on wooden columns or walls and floor of wire mesh, a roof of iron sheets supported by iron poles.	Where non-durable wood species are used, the supporting columns could be attacked by termites and decay, buckling is experienced where the structure is overloaded as is common with a number of farmers. This in some cases result in the total collapse of the structure	Decayed or broken components are often replaced

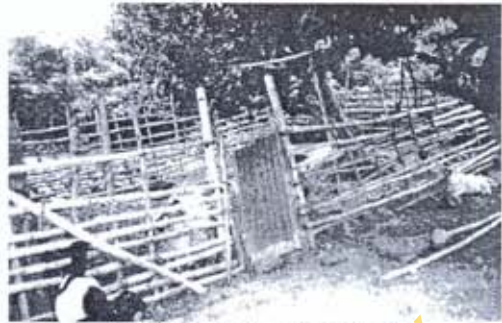
Plate 2: A livestock yard

Yards and sheds	A yard is a piece of land fenced to restrain the movement of animals either temporarily or on a long term. The fences of the yards found were mainly from sawn timber, small diameter logs and split bamboo. Simple sheds made of wooden columns and thatched roofs or those from corrugated iron sheets may be provided within the yard to offer protection against sun and rain. The floor is of rammed earth.	There are usually no serious problems except that occasionally animals may damage part of the fence in an attempt to escape while some of the materials may give way due to old age after a long period of use	Replacement is usually the remedy
Pens.	The floor is of concrete and the dwarf wall could either be sawn timber, plywood or sandcrete blocks. The roof is corrugated iron sheet attached to timber truss. Where it is available, bamboo could also be used for the walls and roof.	Pitting and cracking of floors are in some instances experienced. Where wood serves as walls, it rots with time due to water for cleaning	Wood replacement and floor replastering are the remedial measures

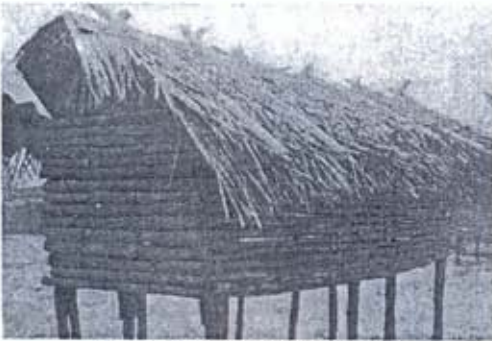
Plate 3: A traditional crib

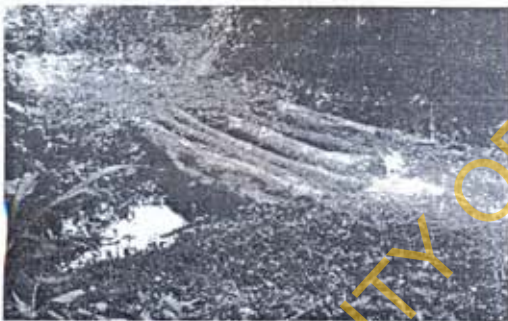
Plate 5: Oil-palm trunk bridge

Bridges	Rural communities make use of bridges constructed on roads passing through the area and where the need arises to cross a river that cannot be waded through, emergency pedestrian bridges are easily put in place by placing a log of wood or oil palm trunk across a river. The few bridges strictly meant for farming activities are mainly constructed by timber contractors for the haulage of logs and produce buyers then use such bridges. The bridges are constructed from logs and oil palm trunks.	Because the bridges are not properly constructed especially the assembly, the members are regularly displaced and in rare cases may break or fall off.	Whenever there is displacement, the logs are rearranged and if some are bad they are easily replaced with the components that can be obtained within the environment
Palm frond woven basket	Flat-bottom and arch-shaped housing type of basket woven wholly from fibrous palm fronds. The bigger ones are used for transporting animals.	The component decay with time as a result of poultry droppings	Since the materials of construction are readily available, repairs are usually not considered and the structure is replaced whenever it can no longer serve its usefulness.

Rural communities make use of bridges constructed on roads passing through the area and where the need arises to cross a river that cannot be waded through, emergency pedestrian bridges are easily put in place by placing a log of wood or oil palm trunk across a river. The few bridges strictly meant for farming activities are mainly constructed by timber contractors for the haulage of logs and produce buyers then use such bridges. The bridges are constructed from logs and oil palm trunks.
